# El Toro – Clute Energy Efficiency Trial

# Project Implementation

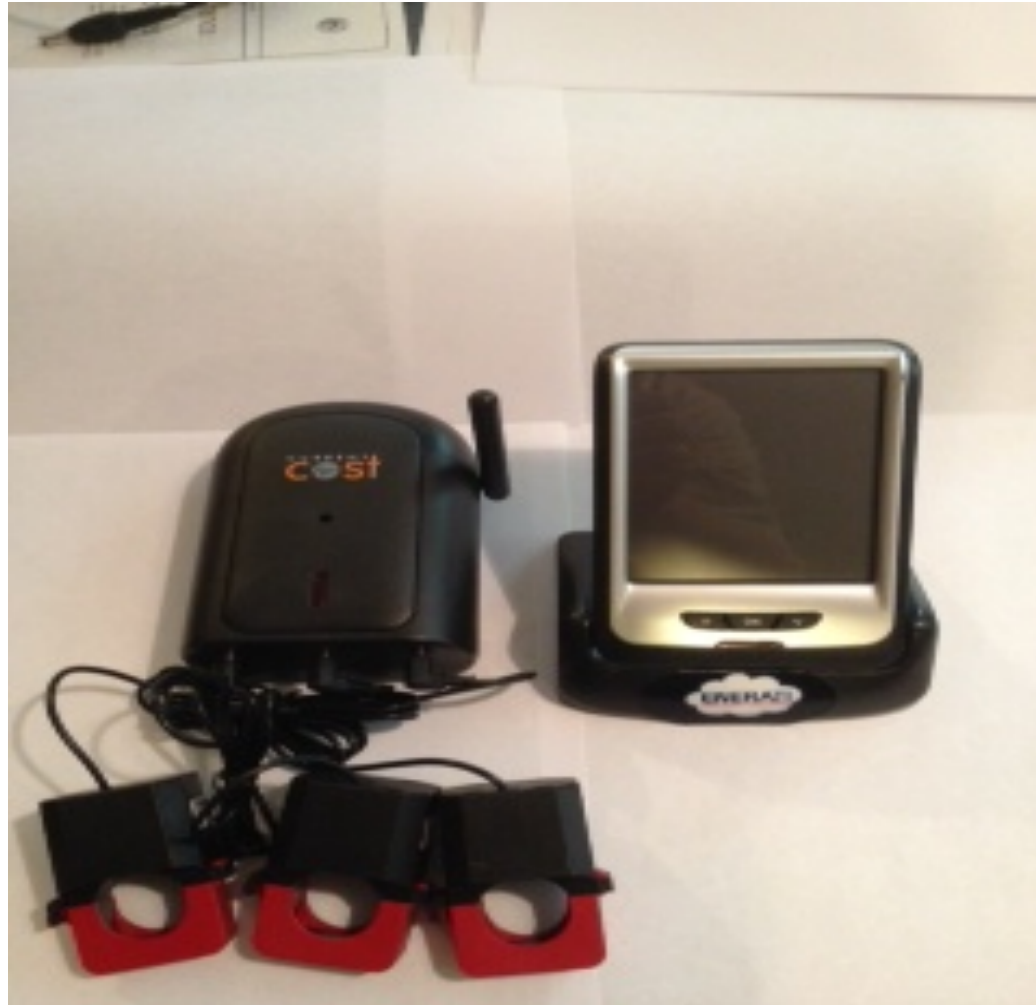
# Data Logging Equipment

(Records KWH energy usage)
