**THERMA-COTE BRAND CERAMIC INSULATIVE COATING
ENERGY USAGE TEST
FINAL REPORT**

LYEFFION ELEMENTARY SCHOOL

Al. Hwy 83
Evergreen, Alabama 36401

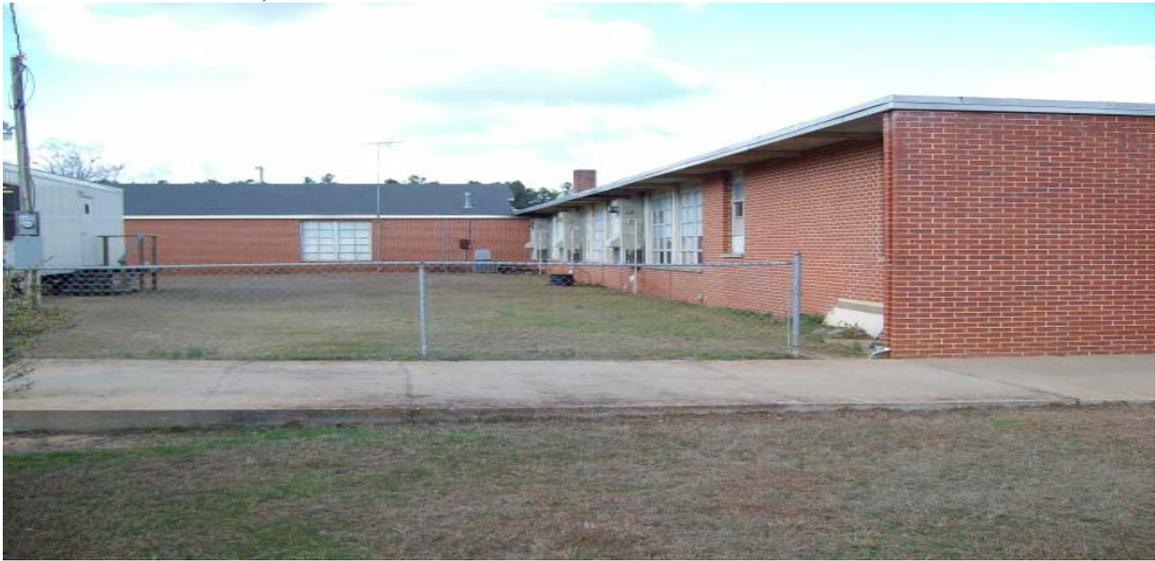
Figure 2: WEST SIDE NORTH END OF FACILITY. CLASSROOMS TESTED ARE TWO NEAREST IN PHOTO, 12 BEING THE NEAREST.

Classroom #12 was chosen to be coated with the product with the adjacent classroom #11 assigned as the control comparison. After room preparation, ceiling and upper 3 rows of frosted glass were coated with 20 gallons of product while the roof was coated with 15 gallons. Jalousie windows at top of common walls with hall were sealed off with sheet plastic to minimize infiltration from the hallway. Per manufacturer recommendations, material was allowed to cure for two weeks before monitoring began. In the interim, meter bases were installed and wired in between the service disconnects and the line voltage lugs on the air conditioners. On July 5, 2009, thermostats were set at 80 degrees, the meters were plugged in and the doors to the classrooms were pulled to and locked as were the entry doors to the building. Routine walkthroughs were performed to insure no tampering had taken place. Photos of the building exterior the interior of the rooms and the meter readings are attached.

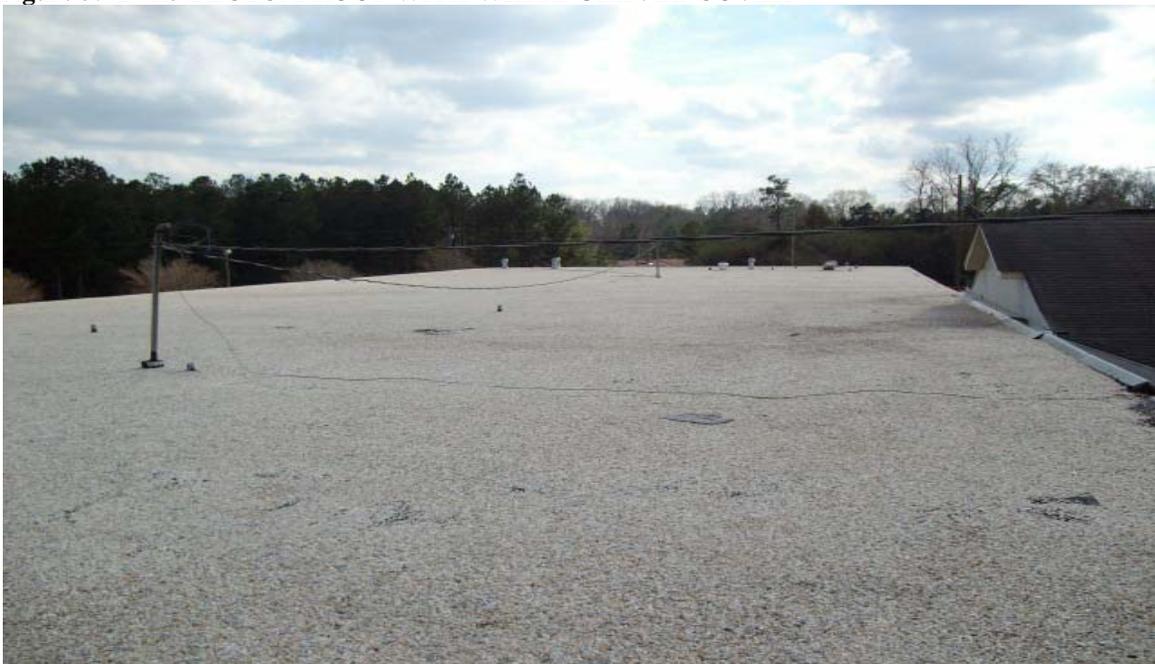
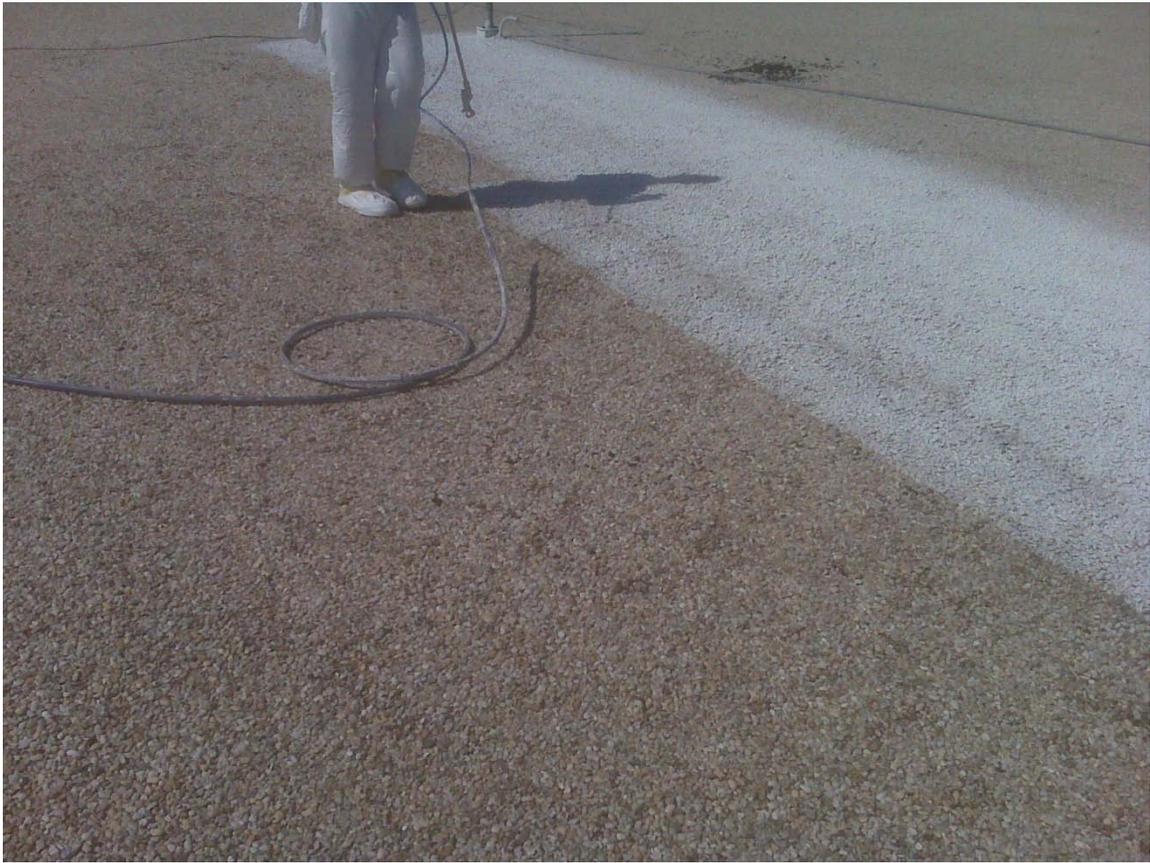
Figure 3: 2" R3 TECTUM ROOF WITH WHITE GRAVEL COVER

This calculates into a 36.1% reduction in electricity usage for the air conditioner in the coated room as opposed to the usage in the control room. It bears noting that this facility already had a light colored roof coating, (see fig. 3). Application of this material to dark roofs or the underside of roof decking with dark shingles may produce even more dramatic results. In addition, this product has a .83 solar reflectivity as established by the Cool Roof Rating Counsel. This high radiant reflectance may result in reduction in the number of fluorescent tubes needed to deliver an appropriate amount of light to the desktops. This could conceivably result in increased savings on the lighting portion of the bill.

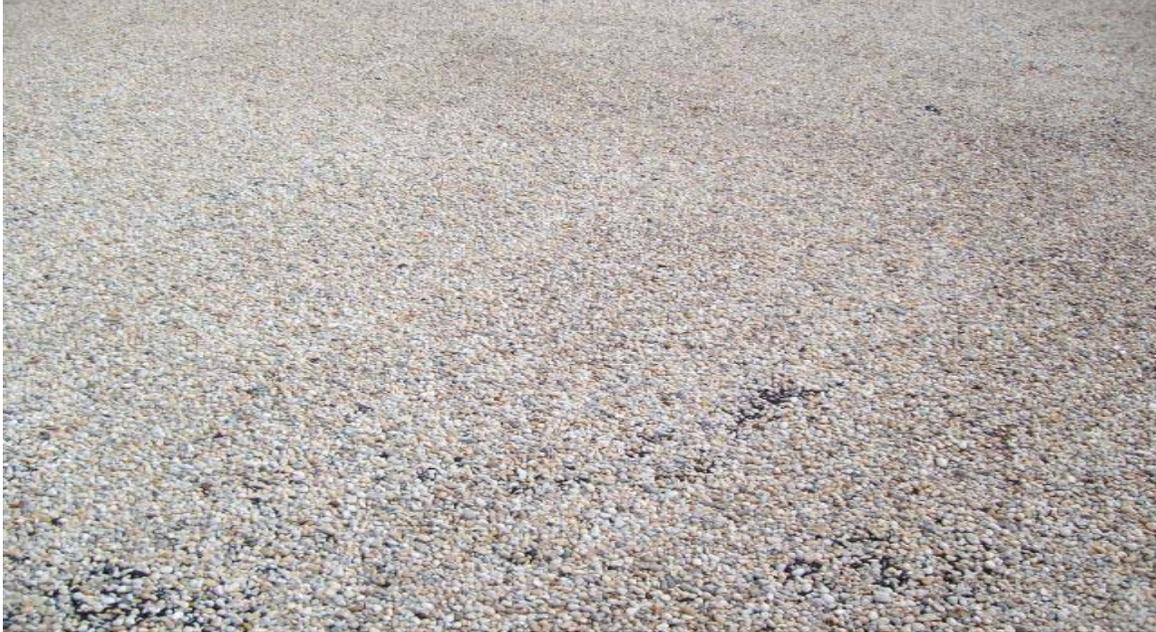
Figure 4: CLOSE-UP OF ROOF COVERING

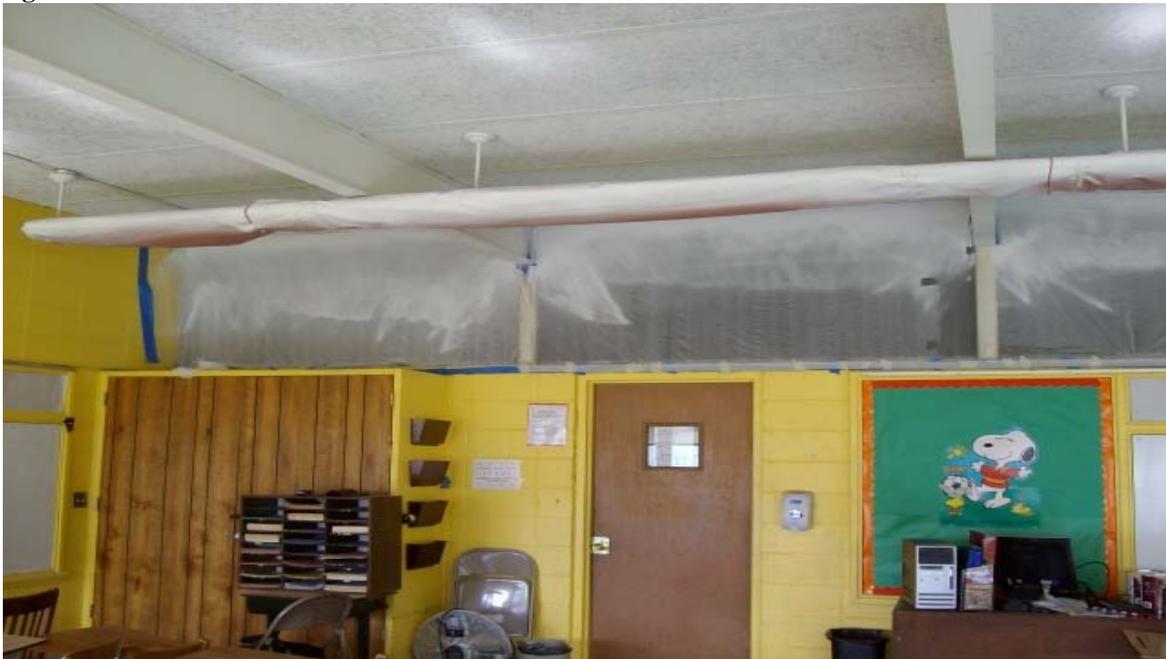
Figure 5 COATED CLASSROOM CEILING

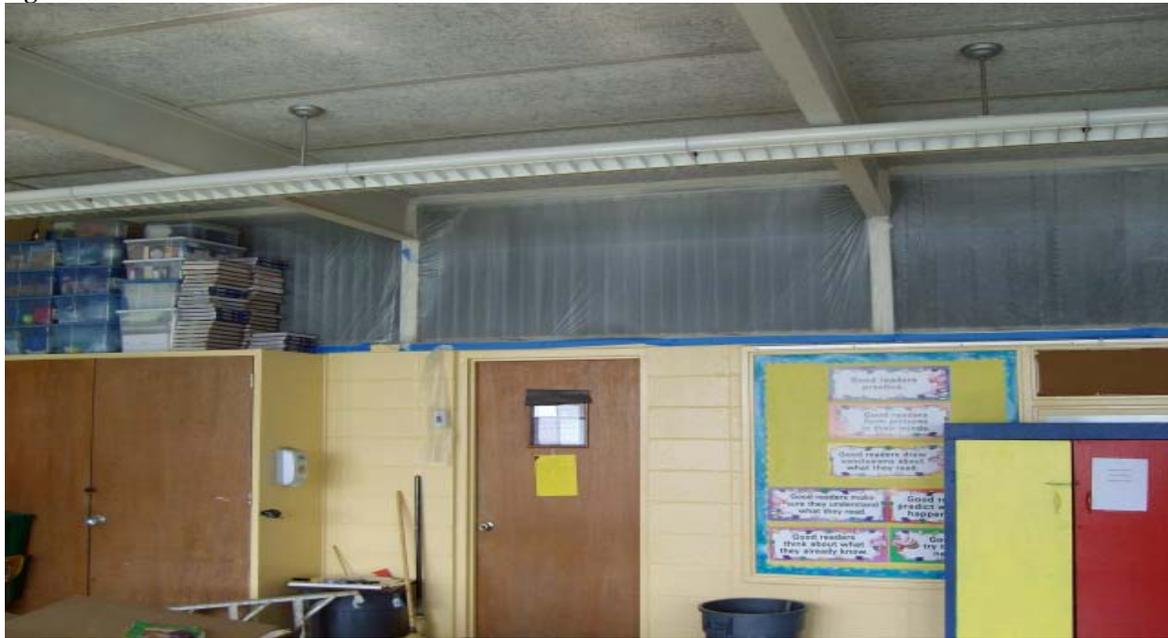
Figure 6: CONTROL CLASSROOM CEILING

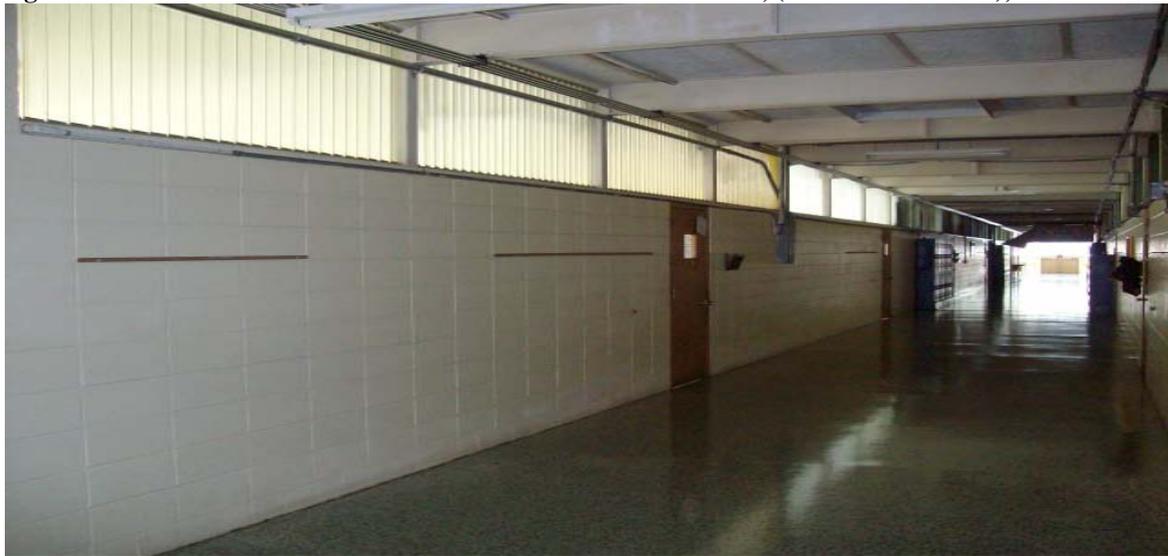
Figure 7: COMMON HALL WALL BETWEEN CLASSROOMS 12, (NEAREST DOOR), AND 11

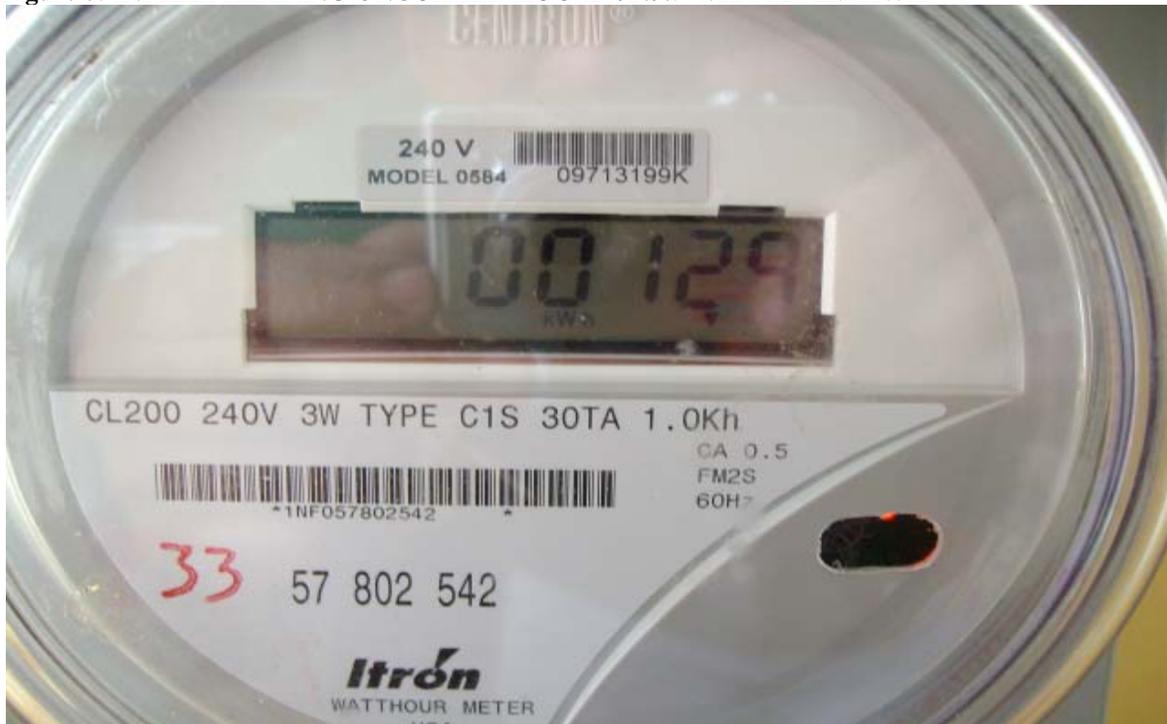
Figure 8: INITIAL READING UNCOATED ROOM 7/10/09 4:11 PM - 129 KWH

Meter readings were recorded on three separate occasions during onsite inspections; these are documented in the attached photos and their captions. Additionally, these meters have an automated reporting feature which provides continuous feedback to Southern Pine. Jeff Kirkland has forwarded a spreadsheet detailing daily usage of each meter and temperature as provided to them by NWS. Reduction of usage was slightly higher during first period than in the second, but marginally so. This could have been due to changes in outside ambient temperature and humidity. Interestingly, the power usage

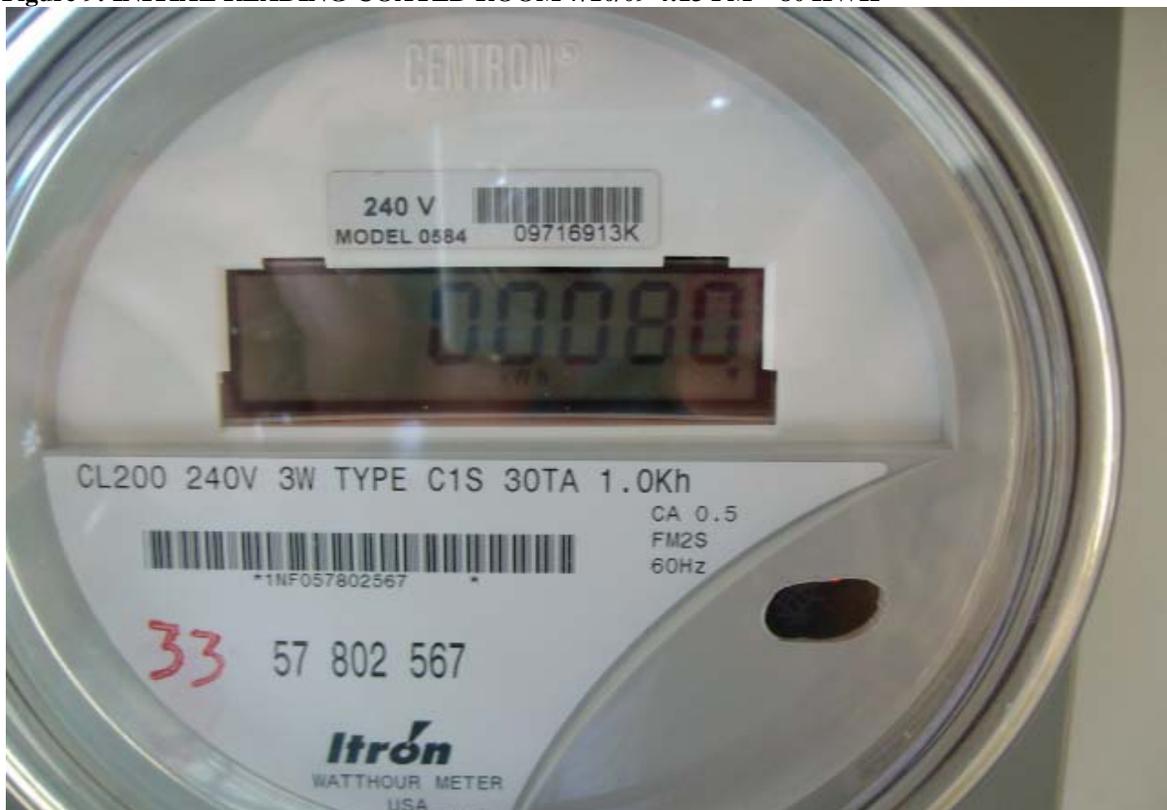
Figure 9: INITIAL READING COATED ROOM 7/10/09 4:13 PM - 80 KWH

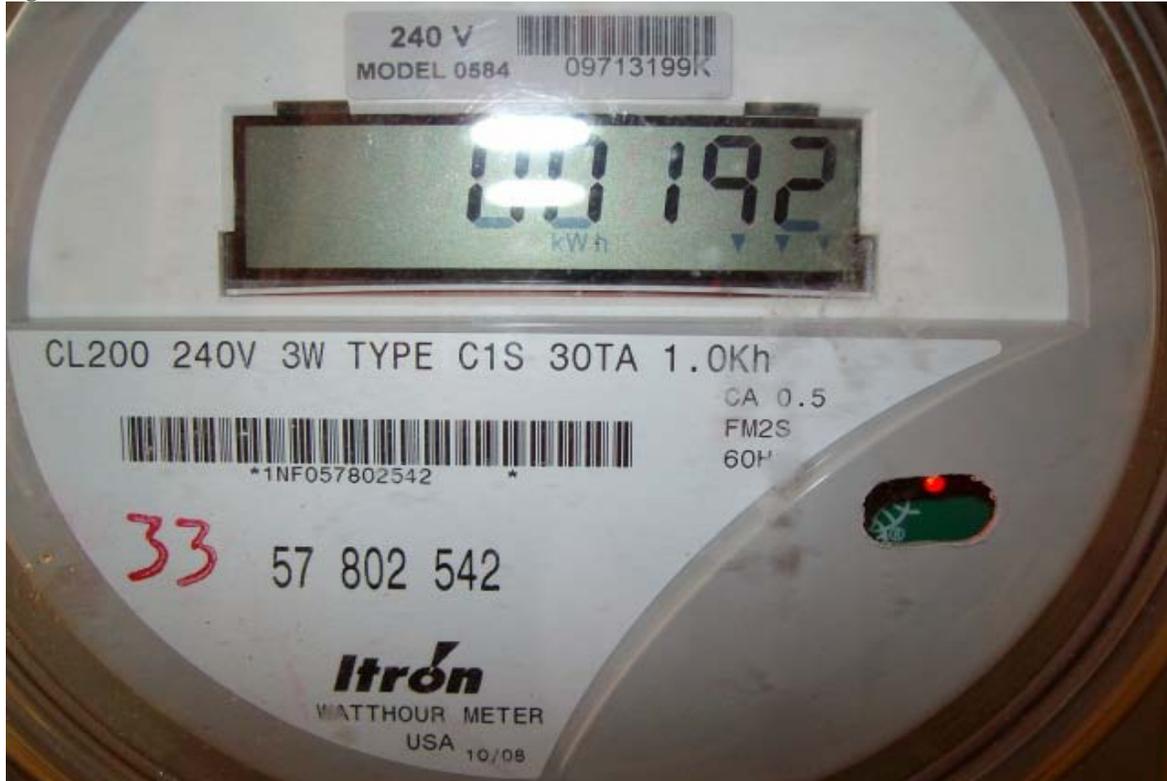
Figure 10: SECOND READING UNCOATED ROOM 7/13/09 2:58 PM – 192 KWH

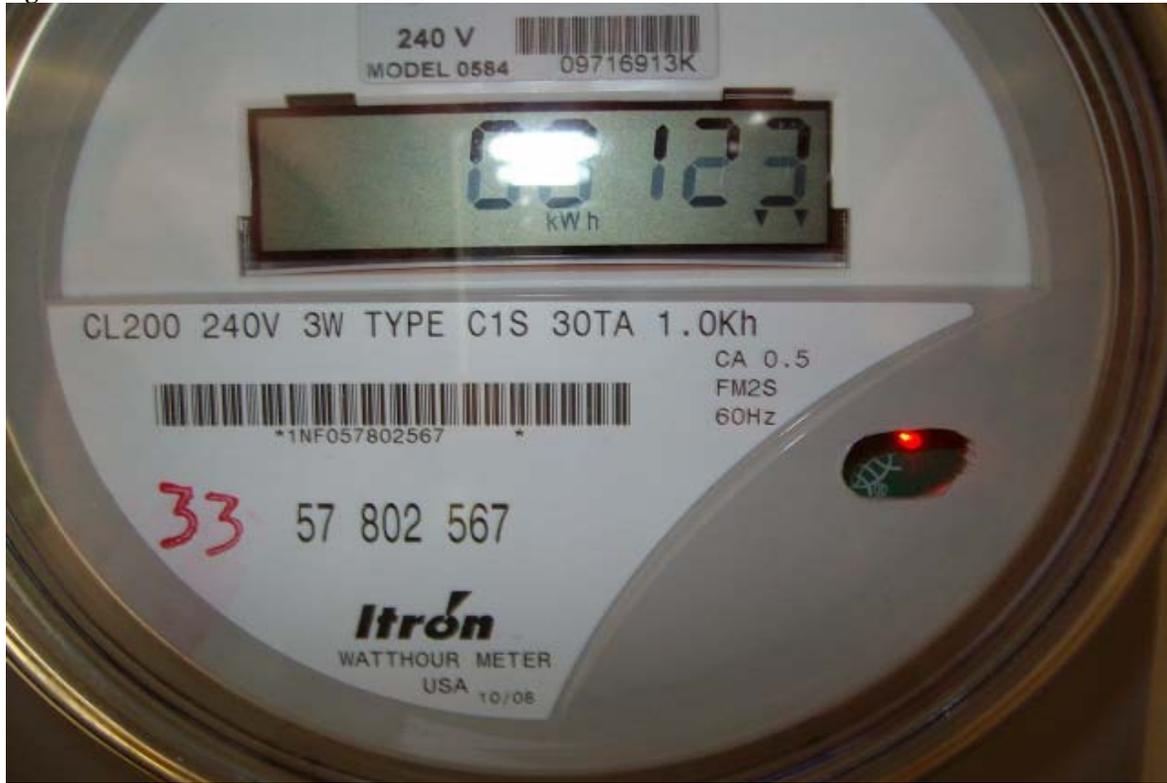
Figure 11: SECOND READING COATED ROOM 7/13/09 2:57 PM -123 KWHD

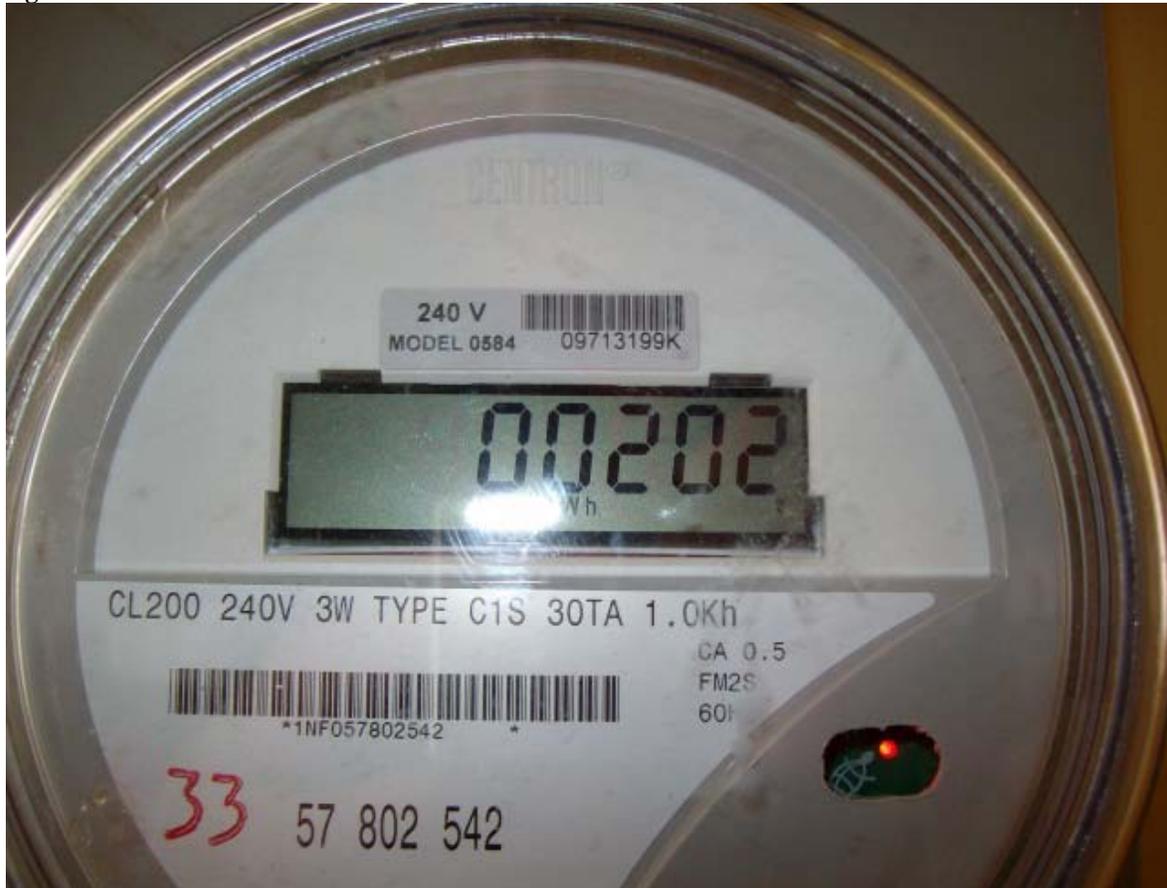
Figure 12: THIRD READING UNCOATED ROOM 7/14/09 12:13 PM 202 KWH

in the last period of approximately 22.5 hours revealed a 40% KWH usage reduction in the coated room. Manufacturing representatives have stated that the product will not attain its optimal performance until it has cured for several weeks. Latest reading shows the following:

| COATED ROOM | 129 KWH |
| UNCOATED ROOM..... | 202 KWH |

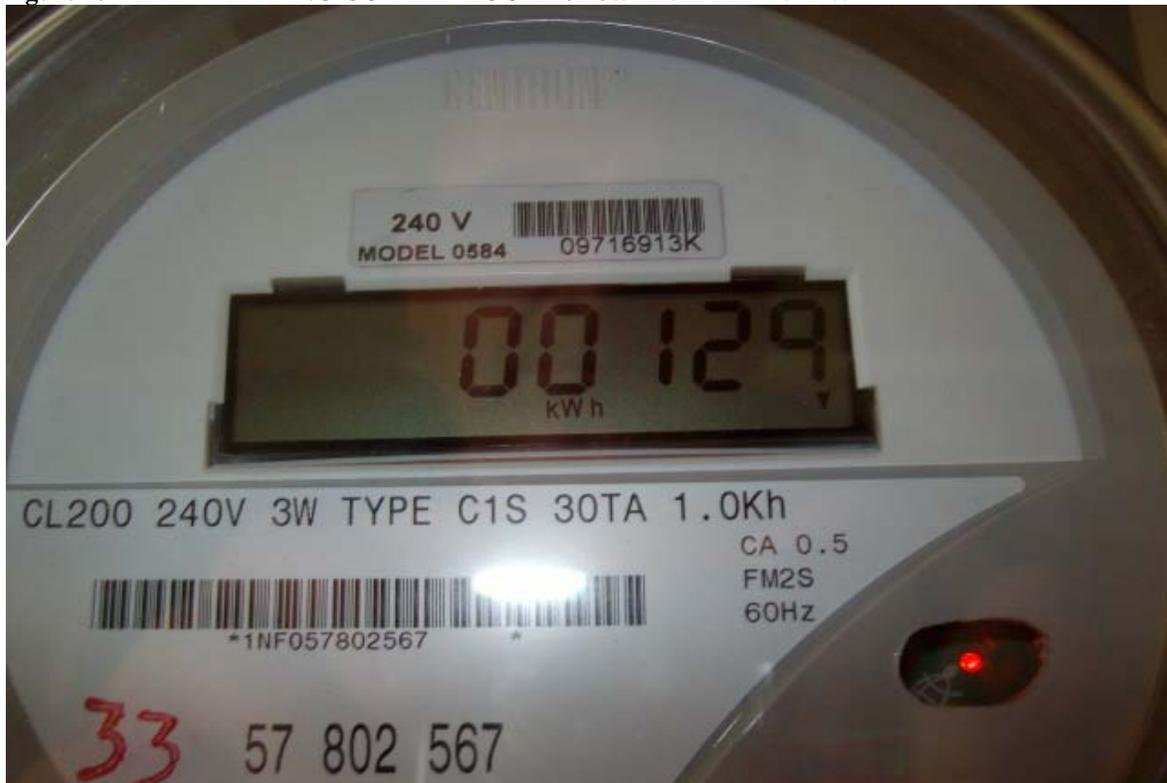
Figure 13 THIRD READING COATED ROOM 7/14/09 12:12 PM 129 KWH
